Radon Inspection Report

Measurement of Radon Concentration in Indoor Air

Report No.: 2700005918201803261620 Report Generated Date: 3/26/18
 Serial No.: 2700005918

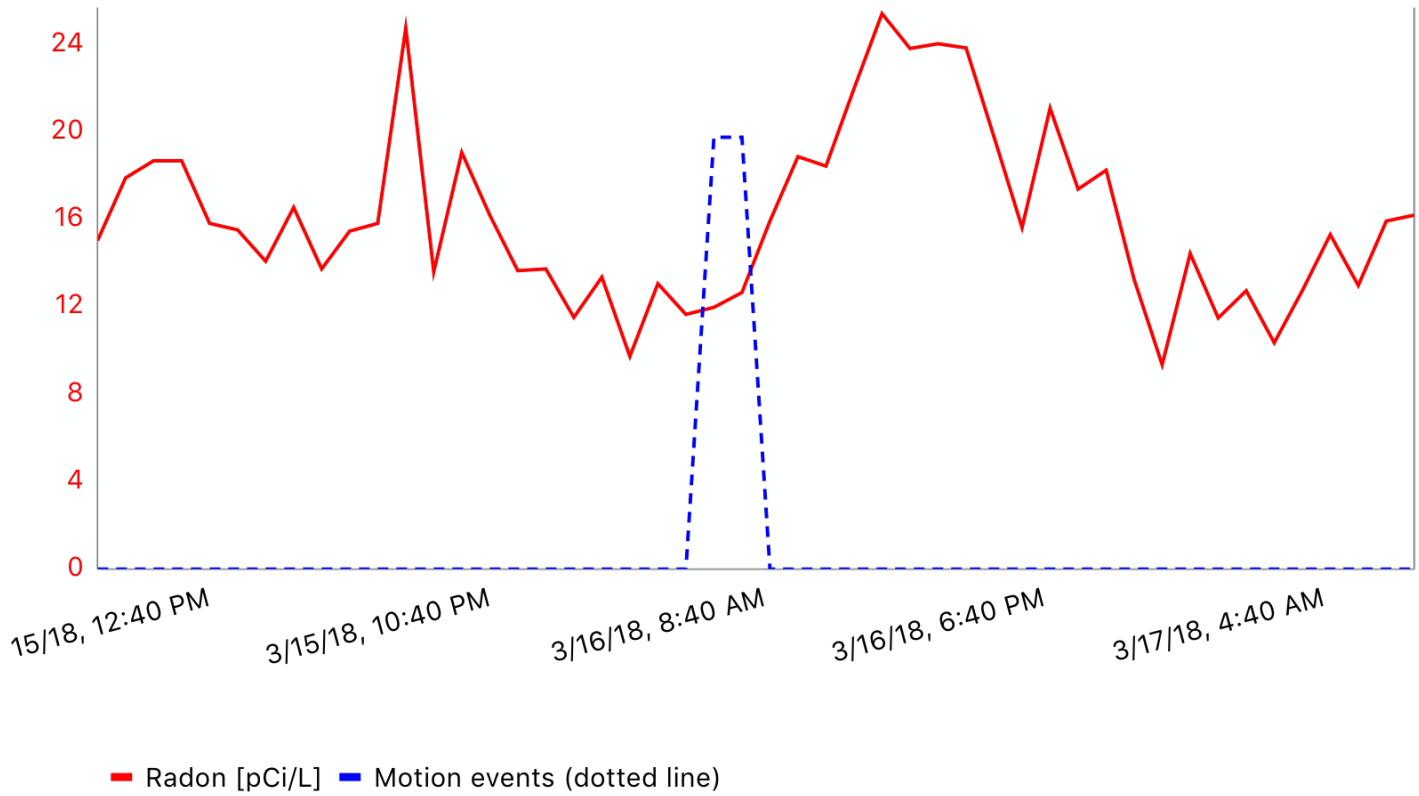
Radon and Movement Chart

Min	Max	Average
Radon [pCi/L]	9.4	25.4	16.1
Temperature [°F]	63.7	70.2	66.4
Humidity [%rH]	32	35	34
Pressure [kPa]	98.72	100.08	99.42
